# Maggs & Allen

## **Building Survey Report**

Sample Property

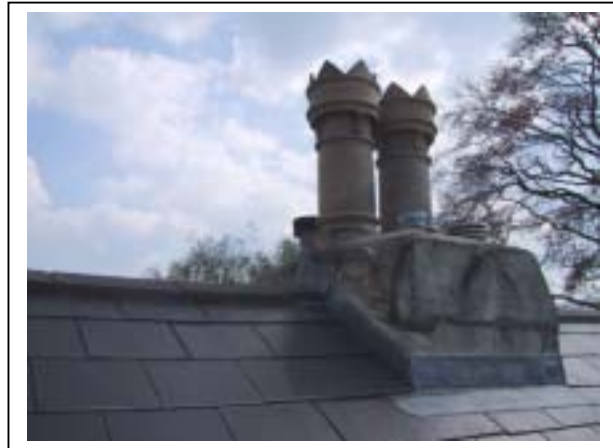
2. This is a relatively small Bath stone built chimney stack shared with the adjoining property and serving to support one clay pot and a gas flue cowl.
3. The chimney is considered to be in reasonable structural order.
4. The stonework is in fair condition, there are some slightly spalling sections but not of a significant nature and no further immediate attention is required.

5. We would advise that the redundant flue be capped and ventilated to prevent possible damp penetration and condensation problems.

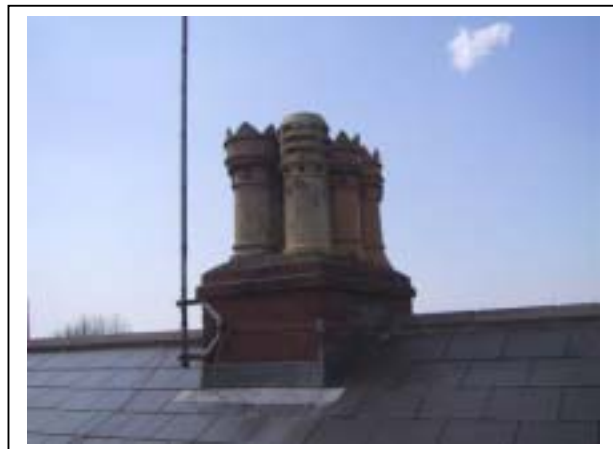
##### Rear Left Hand Side Chimney Stack

6. This is considered to be a more recent brick built structure, also shared with the neighbouring building.
7. The chimney stack is plumb and square and in sound structural order.
8. Brickwork and pointing are in relatively good condition with no significant disrepair.

9. The three clay pots are in good order but again we would advise that the redundant flues are capped and ventilated.

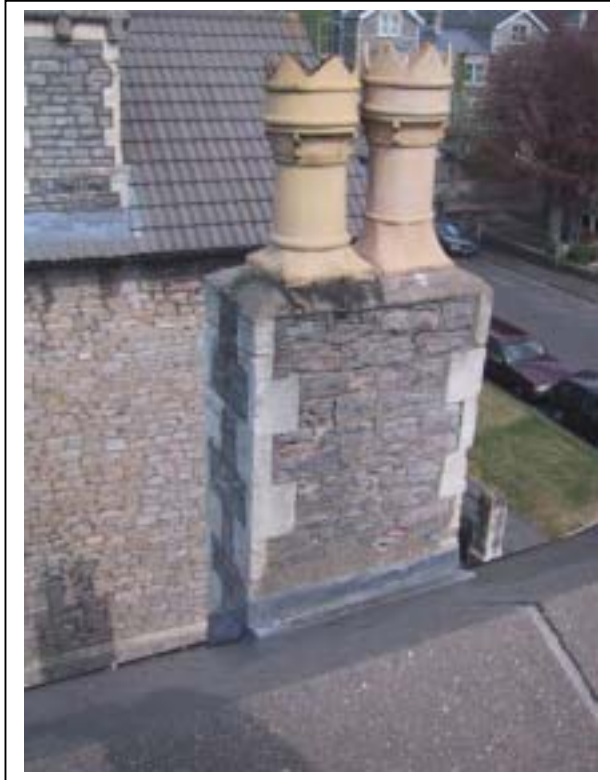
10. This is a part random coursed, part Bath stone built chimney stack.
11. The structure is a little off square but not considered to be significant and otherwise structurally sound.
12. The stonework and pointing is in fair condition, some minor repointing is required but not of an urgent nature.
13. Some local refacing was also noted to some of the freestone sections but again not of a significant nature with no further immediate attention required.
14. The three clay chimney pots are in good order but we would advise that the redundant flues be capped and ventilated.

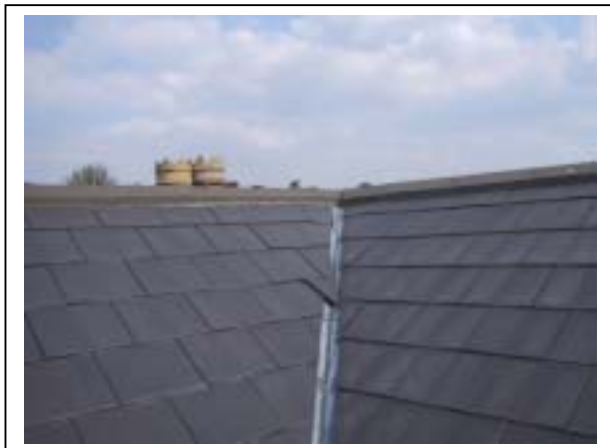
1. The main roof is of a multi-pitched construction with effectively three main roof sections, the main front gable roof area with the ridge line spanning from front to rear and two smaller front and rear roof sections with the ridge lines spanning from side to side.
2. It is evident that the roof has been re-covered in the not too distant past.
3. The roof ridge lines and profiles are relatively even with no significant sagging or deflection.
4. The concrete ridge tiles and sand and cement bedding is in generally good order.
5. The reconstituted cement slates are in generally good order but a couple of broken tiles require replacement to the front facing rear inward slope, also a slipped tile to the front inward facing valley gutter requires repositioning.

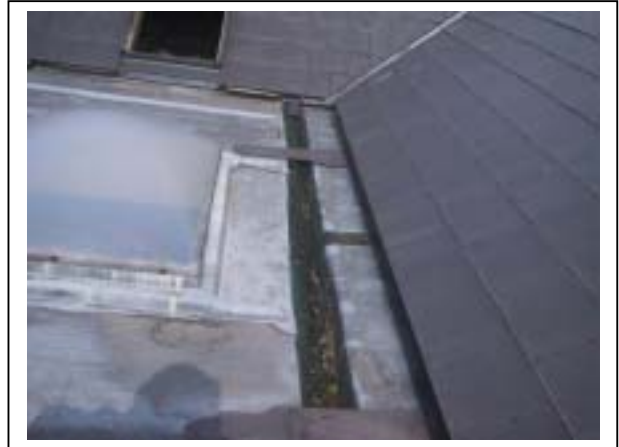
2. This covering has evidently also been renewed in conjunction with the main roof re-covering. As far as we can ascertain the lead sections are to a reasonable size and specification, there is some slight evidence of ponding which indicates that the fall could be improved but this is difficult to ascertain the recent very dry conditions. We noted no evidence of any significant problems and on the whole the leadwork has been laid to a reasonable standard.

3. There is a small section of oversized leadwork adjacent to the front roof slope but a rubber expansion gasket has been incorporated.

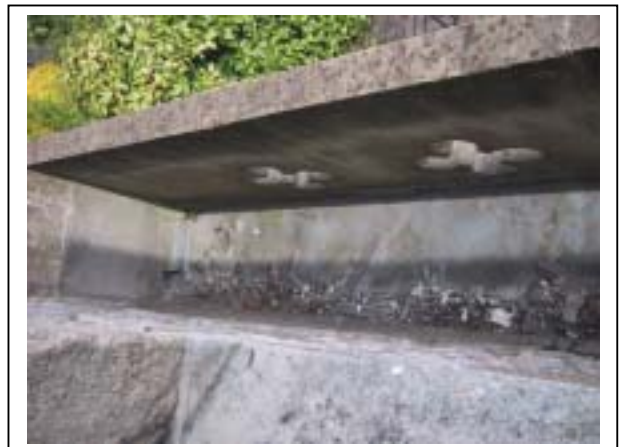
#### Front Bay

4. There is a small zinc covered roof to the front bay. Although no signs of any current leakage problems, we are of the opinion that this is of some significant age, the roof also evidently falls back to the main building and there is evidence of previous problems. The flashings at the wall abutment are also particularly poor and we are of the opinion that this roof covering is now approaching the end of its useful life and we recommend that it be replaced with leadwork as soon as possible.

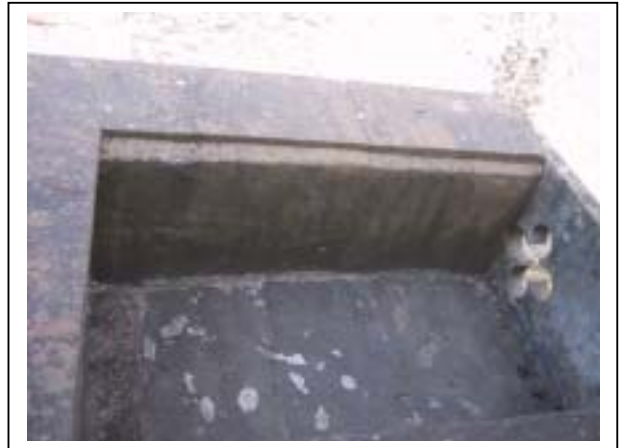
### Entrance Porch

5. This is also a small zinc covered roof, further overpainted at some stage with bitumen. This covering is also of some significant age, the layer of bitumastic paint also indicates that problems have been experienced and once again we are of the opinion that it is at the end of its useful life and recommend that it be replaced with leadwork as soon as possible.

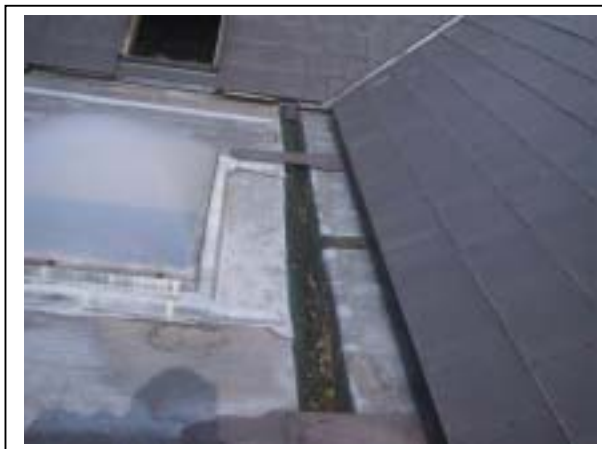
1. A small fibreglass box valley gutter has been formed to the flat leaded roof section. This is currently in satisfactory condition but there is already evidence of leaves collecting in this valley, despite the use of the wire meshing and clearly it will require monthly inspections to ensure that it is kept free from blockage and obstruction.
2. Sectional lead lined valley gutters have been formed at the front and rear main gable, also the small secondary gable and roof abutments, and these are all in good condition.

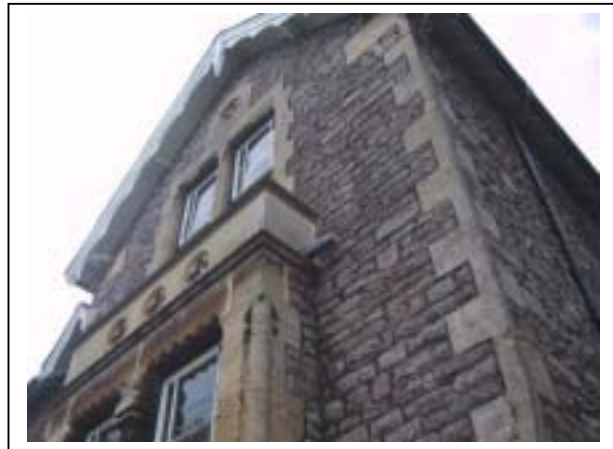
4. We recommend that a downpipe facility be provided to the front bay roof as this outfall is discharging water onto the front wall and we believe causing some of the internal damp penetration problems evident.

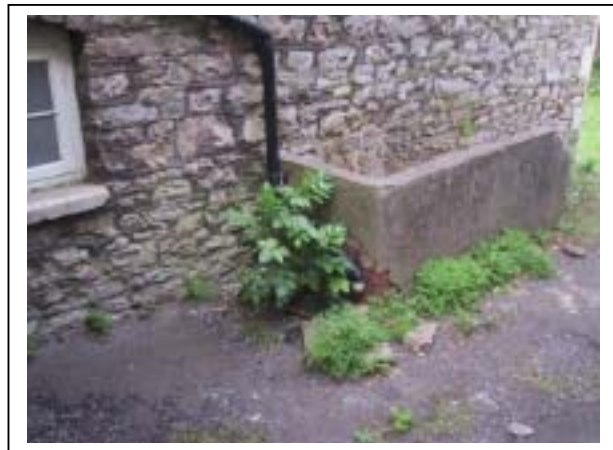
5. The downpipe from the entrance porch currently discharges directly onto the site ground, we would also recommend that this is connected to a surface water drainage system.

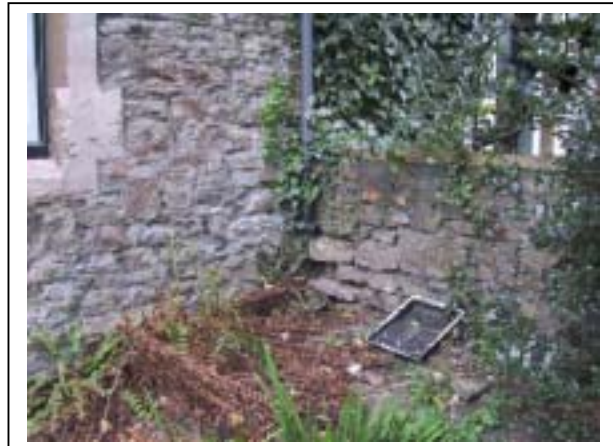
6. The downpipe to the rear left hand side of the building also discharges onto the site ground, this should also be connected to a surface water drainage facility or soakaway.

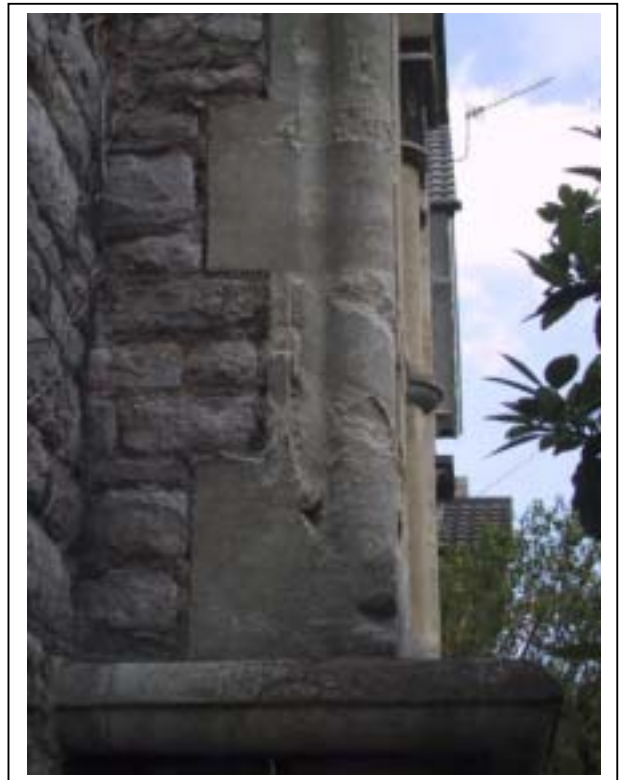
5. Some more significant refacing is required to the stonework of the front bay, particularly to the detailed stonework of the bay sides and also the decorative finial of the central column. The cracked sill also requires repair.

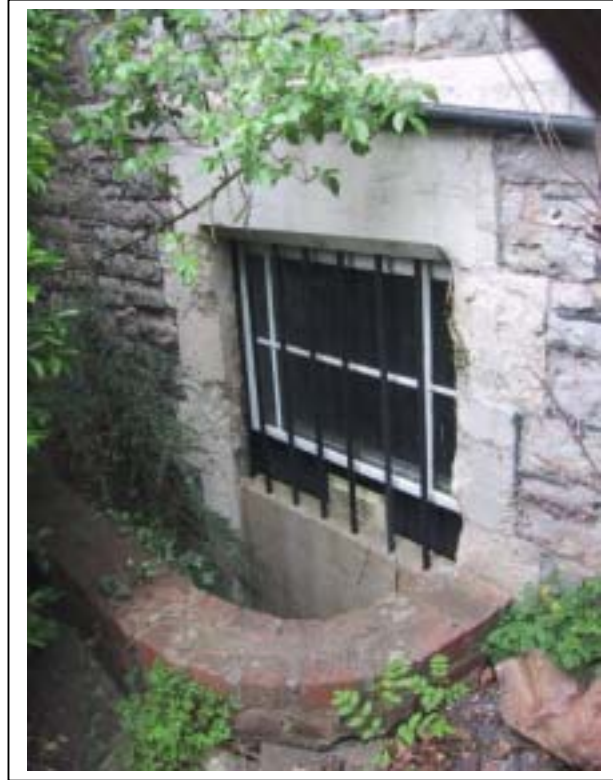
7. The stonework at basement level however is poor, there is some significant deterioration of the stonework, to such a degree where now replacement sections are required.

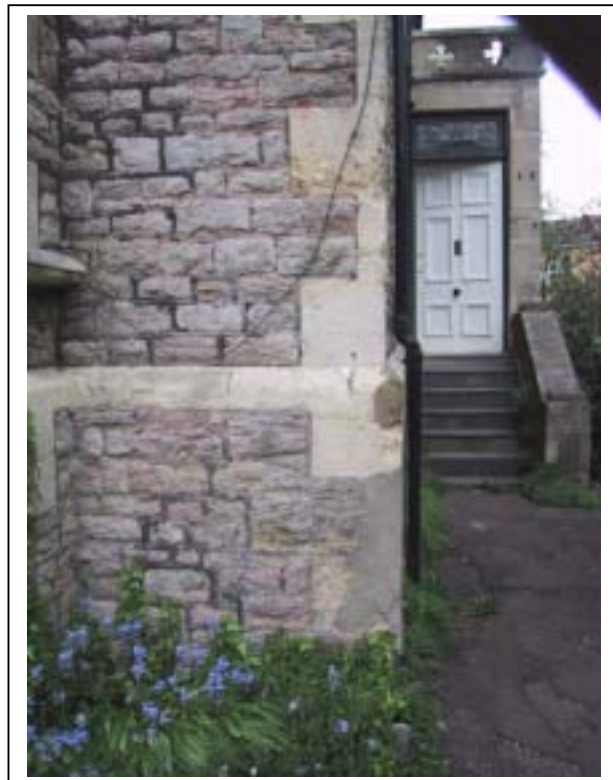
8. Furthermore, the stonework to the wall corner at basement and ground floor level is also particularly poor, replacement sections are also required to this area.

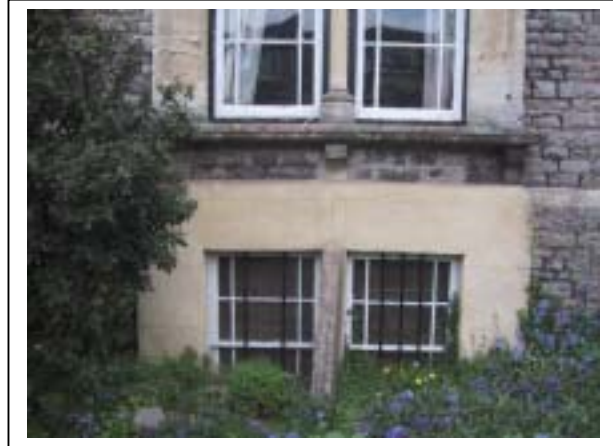
9. The stonework to the basement level of the front bay is notably distorted, this has at some stage in the fairly recent past been partially refaced. Such work has not been carried out to a satisfactory standard. This refacing is already failing, cracking was also noted adjacent to the central column and also the front buttress which has no doubt been constructed to prevent any further outward movement of this section.

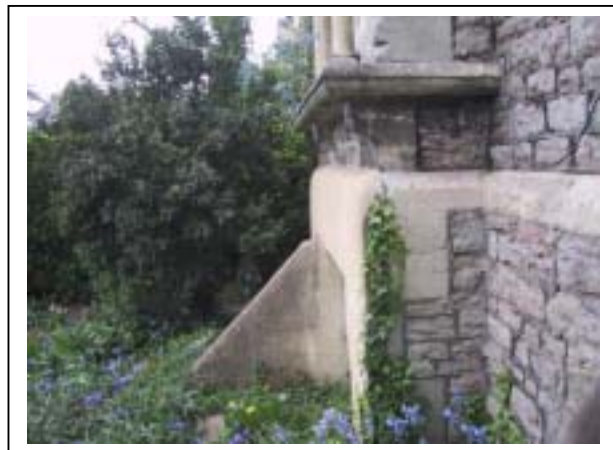
10. As the refacing of this area is now failing we are of the opinion that the stonework behind is likely to be in particularly poor condition. Although there is no evidence of any ongoing structural problems (there are no signs of any cracking or distortion to the bay above), however, there are some further signs of outward movement of the stonework with cracking at the buttress abutment and we are of the opinion that this section of the bay will require reconstruction.

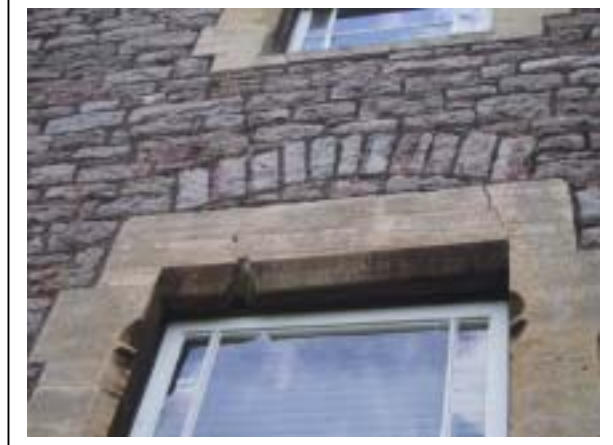
11. The stone lintels to the top floor are in reasonable condition, some slight cracking was noted but considered to be of a superficial nature only. The lintel to the ground floor left hand side is considered to be in poor condition, it has been damaged, cracked and dropped slightly and we are of the opinion requires replacement.

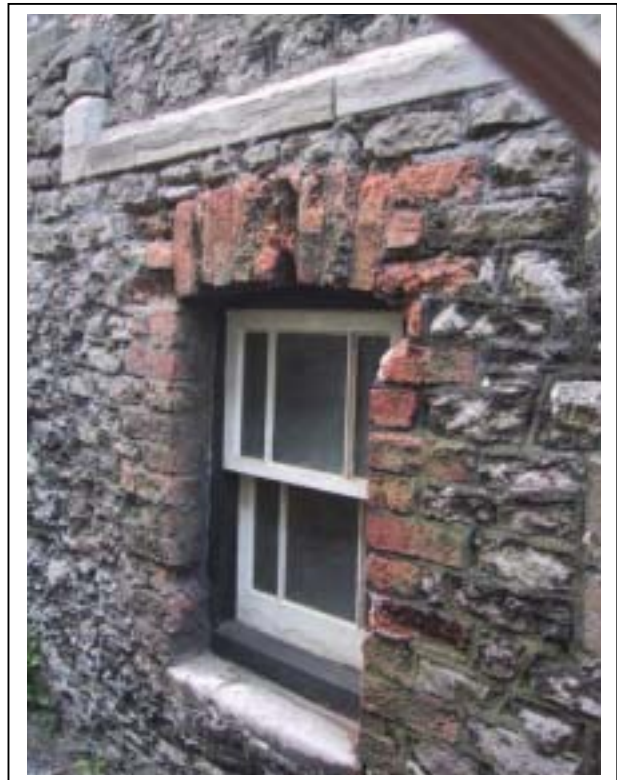
20. The brick lintel to the side basement of the entrance porch area is in poor condition and requires reconstruction.

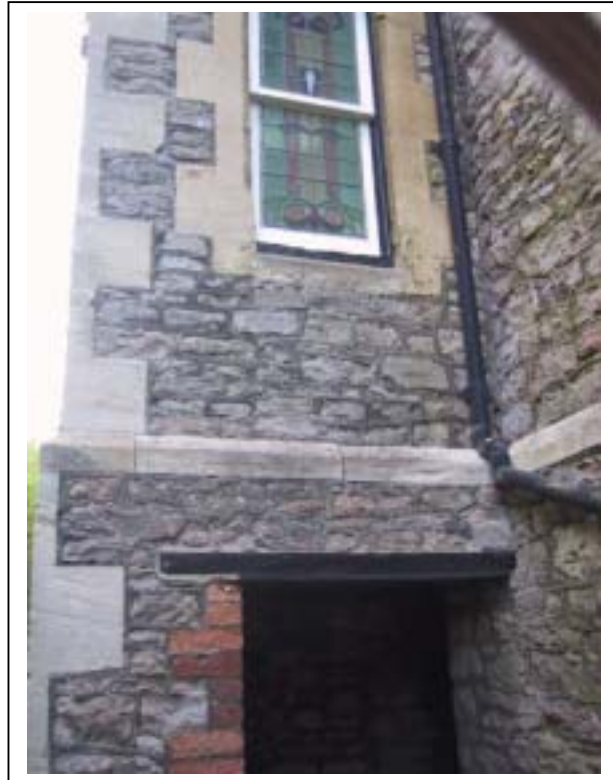
21. The timber lintel over the rear basement door area is also, as far as we can ascertain, beginning to suffer from rot problems, and we would advise is replaced in the near future.

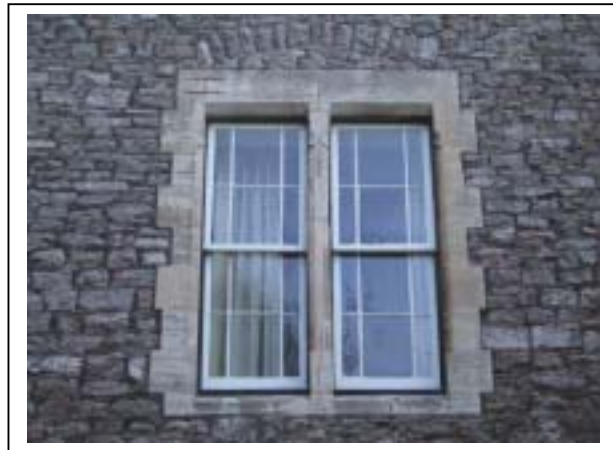
24. The freestone to the main ground floor is in fair condition but there are some significant problems to the central stone column of the right hand side window. This is badly cracked and distorted and further movement cannot be discounted. We are of the opinion that this bay column now requires reconstruction.

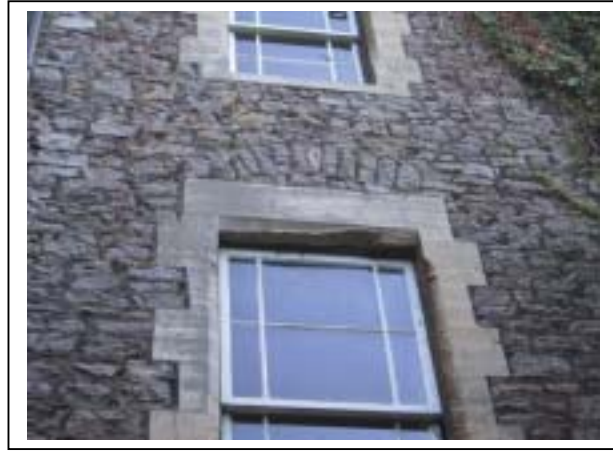
28. The stone lintel to the ground floor left hand side is considered to be in poor condition, there is some significant deterioration to the base of this stonework and we are of the opinion that this lintel is also showing signs of further slight cracking and should be replaced.

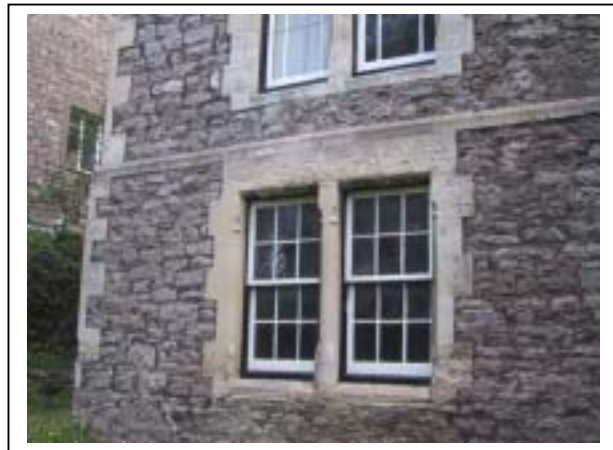
29. The stone lintel is particularly poor to the right hand side basement windows where the stonework appears to be of a fairly poor quality type, this lintel requires replacement.

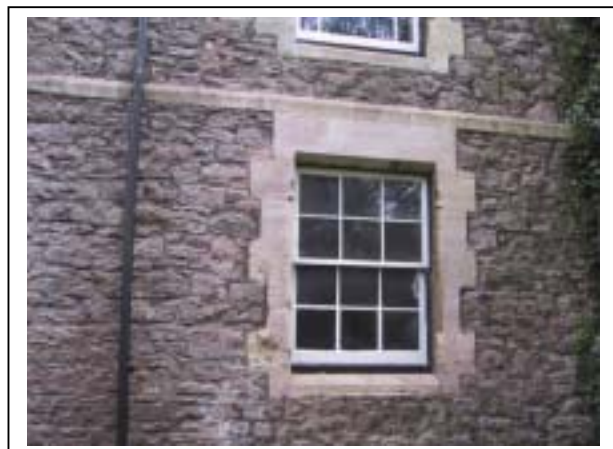
30. There is some moderate cracking to the left hand side basement lintel, precautionary metal bracing over this crack should be sufficient.

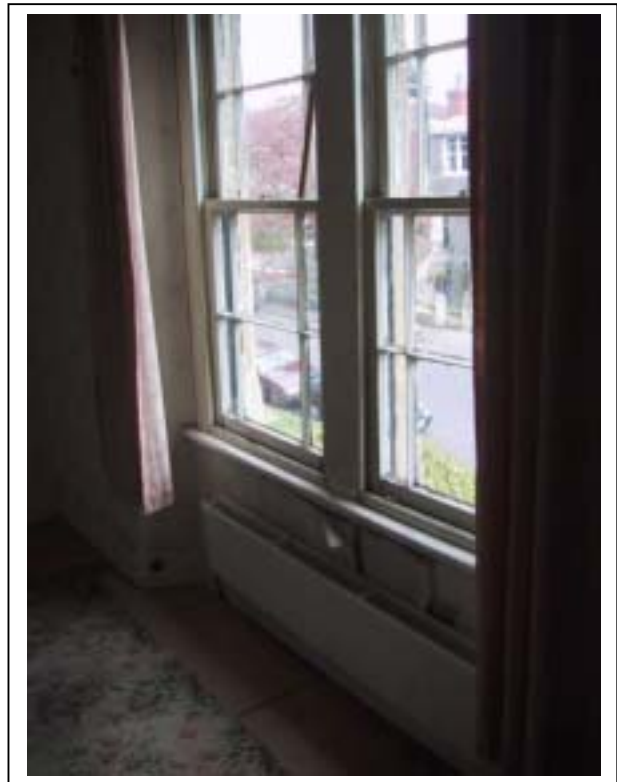
8. There are some large gaps at the framework to the windows of the front first floor, these are obviously extremely draughty and rattly and consideration should be given to the provision of routed draught excluders in conjunction with the refurbishment or possibly replacement at this level.

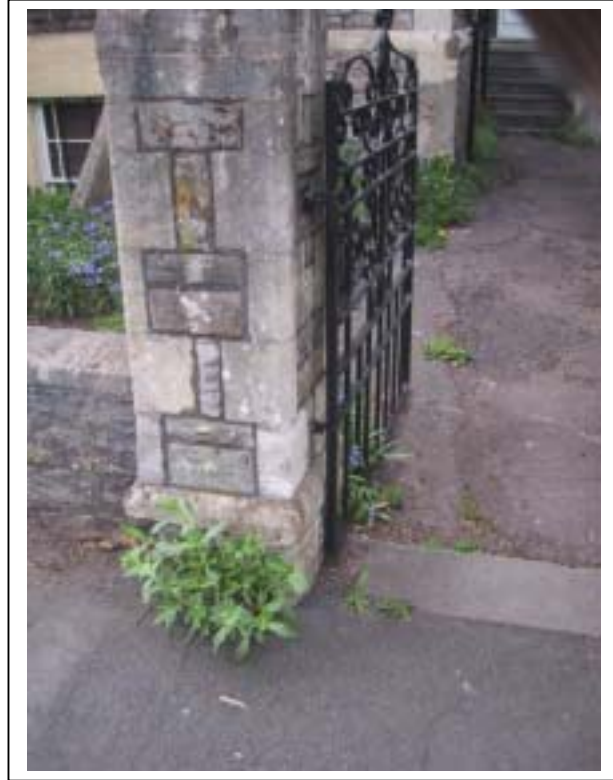
2. The stone entrance columns are suffering from some disrepair, particularly to the base of the left hand side column where replacement stone sections are required.

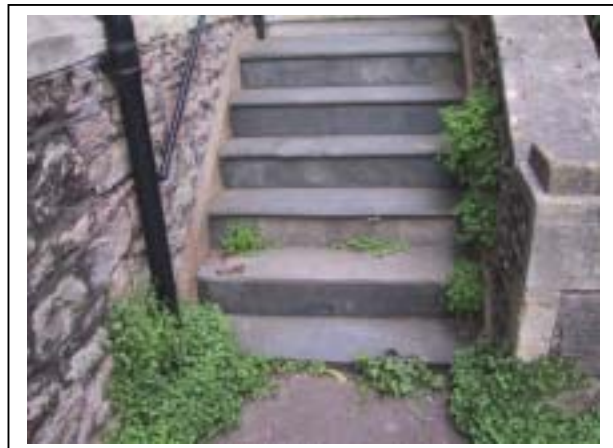
6. The slate entrance steps are in fair condition but one slate step is missing, it has been poorly repaired with sand and cement and we recommend that a slate step be reinstated.

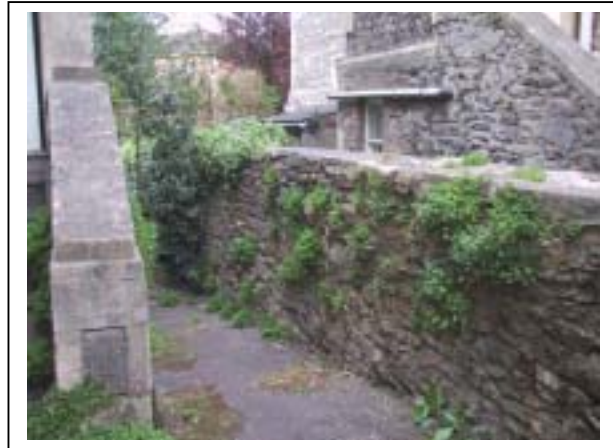
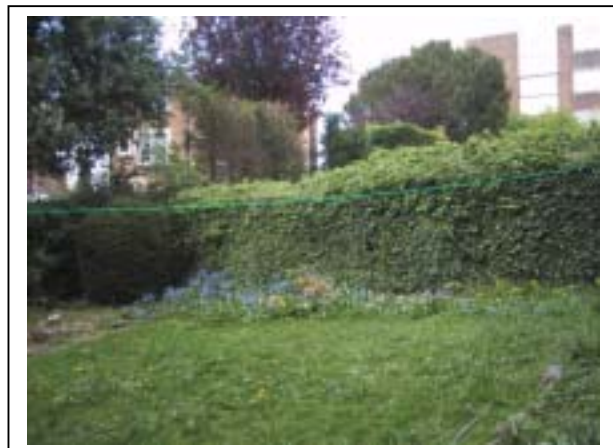
8. The right hand side stone boundary / retaining wall is not in particularly good condition, some poor quality repointing has been carried out and this wall does lean quite notably towards the right hand side neighbouring property. It also bulges and is generally uneven and at some stage in the next few years it is likely to require complete reconstruction and costs should be investigated. The rear section of this boundary wall is completely overgrown, we are unable to fully confirm its condition but we did note that some buttresses have been constructed in the past, no doubt to restrain movement problems, but in view of the general neglect to the property the stonework will no doubt be in poor order. You should budget accordingly.

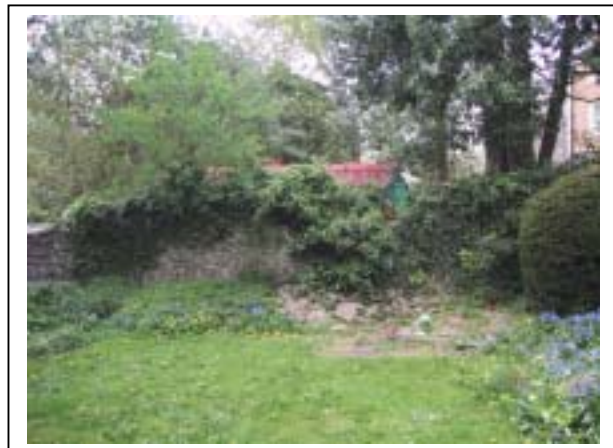
9. The rear most boundary wall has now partially collapsed and is in need of rebuilding.

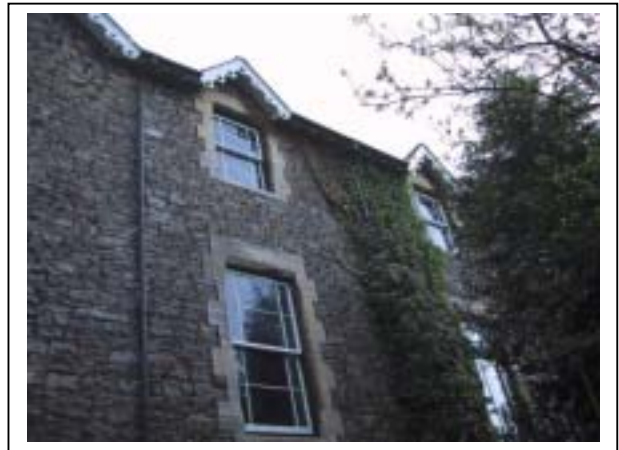
13. We recommend that the Ivy growing to the rear of the property is removed as it is currently encroaching into the guttering and likely to cause problems at eaves level.

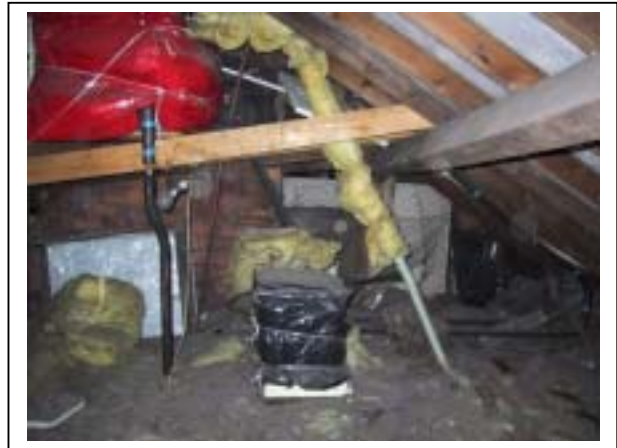
5. There is no formal party wall at the junction of the neighbouring property within the roof space, this does therefore constitute a possible fire bridge and we recommend that a fire resisting party wall be created to both the front and rear roof spaces.

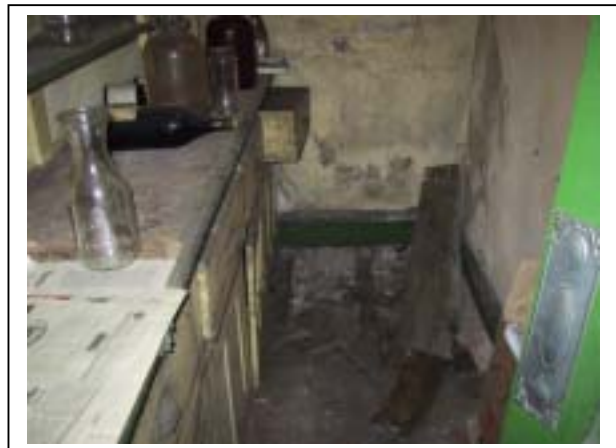
6. Floors to the rear section of the basement are of suspended timber. These are suffering from extensive wet rot, dry rot and woodworm problems and are now clearly at the end of their useful life and in view of the problematic external ground levels and lack of any ventilation, we would advise are replaced with concrete floors throughout.
