BUILDING SURVEY REPORT

SAMPLE REPORT

18 September 2018

T J Maggs MRICS

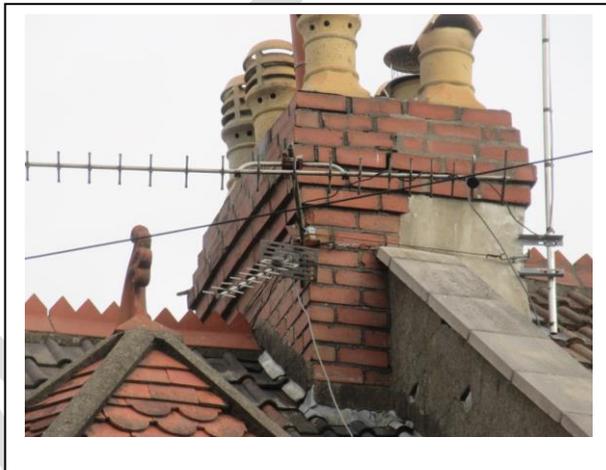
1. The brick party stack is fitted with three pots and one flue terminal. The stack has bowed and the top section is open-jointed. Some localised repointing and potentially partial rebuilding of the upper section of the stack should be carried out within the next 1-2 years. The loose television aerials upon the chimney stack should be taken down and re-fitted as required.

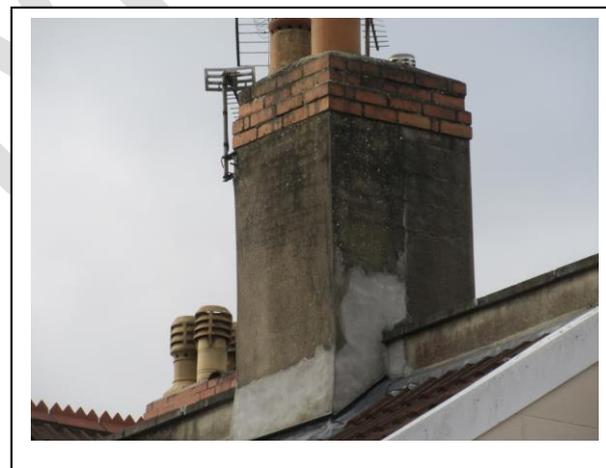
2. The stack upon the back addition roof is constructed of brickwork and partly rendered. The render has been recently patched, however the older render is very worn and, due to signs of dampness internally, we recommend that this stack is completely overhauled. Some open-jointed brickwork at the top of the stack should be repointed at this time.

3. Estimates should be obtained from a roofing contractor for an overhaul of the chimney stacks as the costs will be increased by the need for scaffolding.

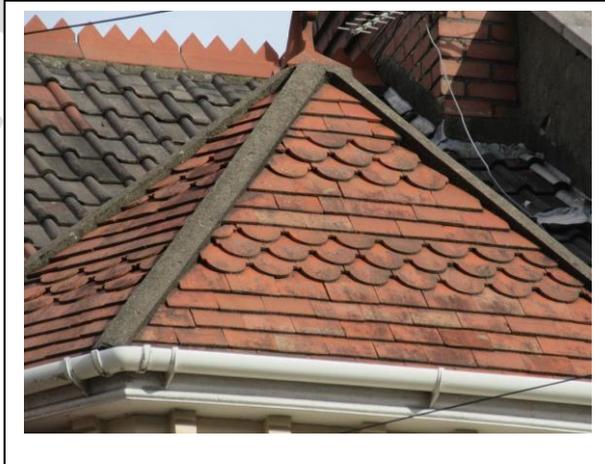
1. The roof above the front bay is hipped and covered with plain and scalloped clay tiles. There are a couple of slipped and worn tiles to the bay roof which will require replacement within the next couple of years. The roof is formed with sand and cement hips and these tend to break up as they age; replacement will be required within the next five years, at which time lead should be used to form the hips.

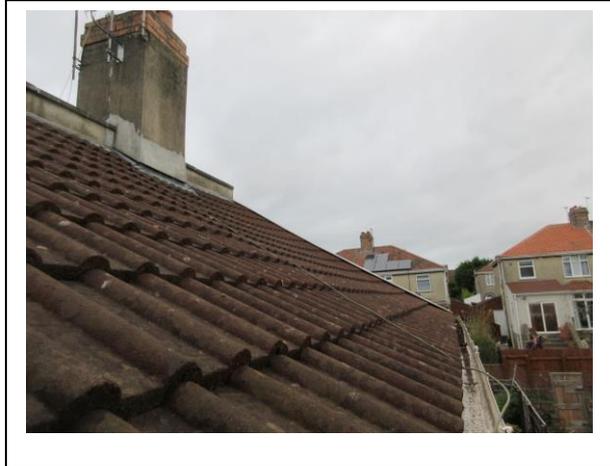
2. The two-storey back addition roof is covered with concrete interlocking tiles. There is evidence of sagging within the roof which is common in properties of this type and due to the undersized nature of the roof timbers. The roof structure has been partly upgraded and timber struts have been fitted between the rafters and ceiling joists, however due to the increased weight of the roof with the heavier concrete tiles this has caused cracking within the bedroom ceiling. Additional support is required to this roof structure or re-roofing will need to be carried out, at which time the existing roof structure should be completely replaced with a more substantial one. A structural engineer should advise as to the size of the timberwork required or whether strengthening of the existing structure is possible. The bedroom 3 ceiling will require replacement at this time.

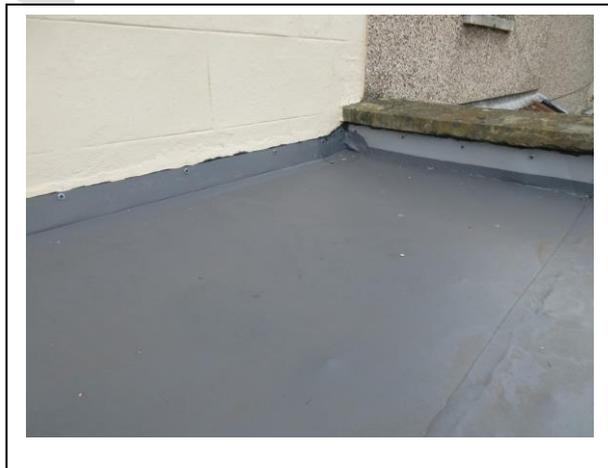
1. The roof above the kitchen extension is flat and formed with a single ply membrane. The roof covering is of a poor quality and the flashings are very basic. We recommend this roof covering is replaced with new flashings to avoid water penetration problems occurring.

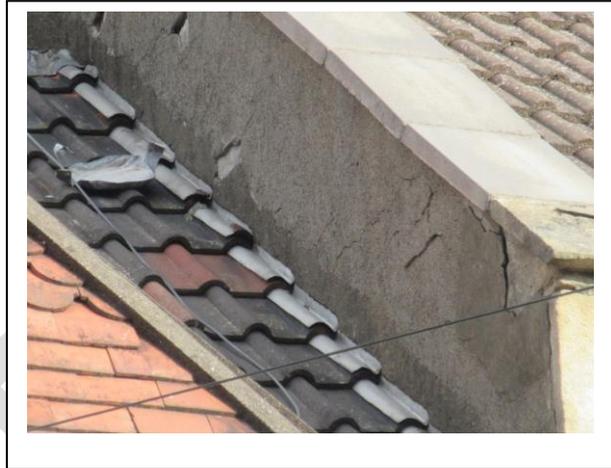
1. The front western rendered parapet wall is covered with concrete copings and in good order.
2. The rendered eastern parapet wall is in very poor condition and the damaged render should be hacked off and renewed. The concrete copings are adequate, although the end stone coping is badly eroded and should be replaced when the parapet wall is overhauled.

3. We recommend that the coping stones are taken up and re-seated upon a damp-proof membrane during the overhaul works.
4. The rear western parapet wall is rendered; the coping stones are too small and new larger coping stones should be fitted to prevent water from running down the wall and leading to dampness internally.
5. The rear eastern parapet wall is satisfactory.
6. The back addition roof parapet wall is rendered and covered with concrete copings which are too small and new larger copings should be provided to avoid water penetration.
7. The stone copings to the single storey kitchen extension roof are old and worn and should be replaced with new concrete copings which incorporate drip grooves.

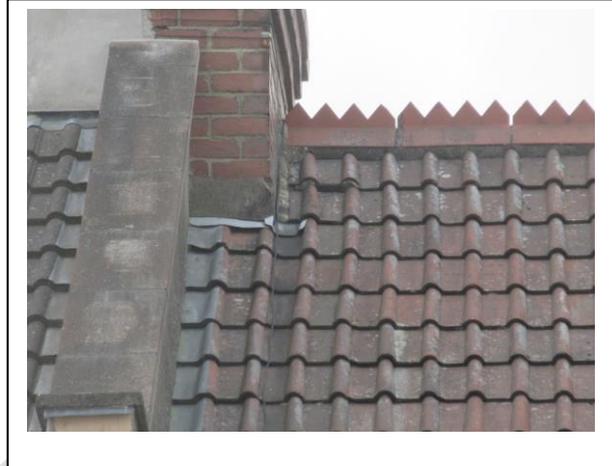
1. The flashings to the eastern front parapet walls are formed from zinc and lead. They are of a poor quality and should be replaced. The flashings to the chimney stack are also very poor and renewal is required to avoid water penetration.

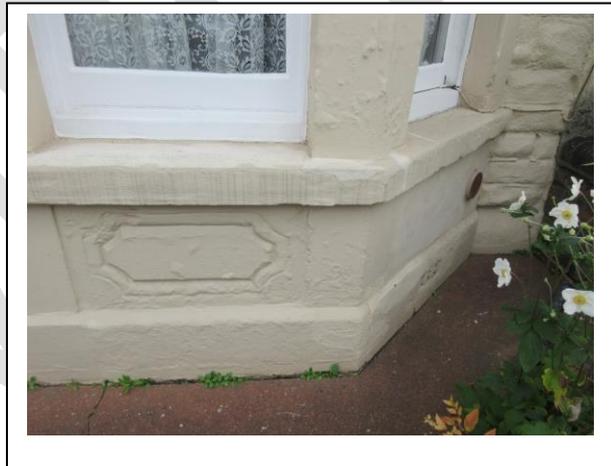
5. There are indications that previous freestone repair works have been carried out and these are of a basic quality, with some rather uneven surfaces. The stonework at the base of the bay has been roughly patched, with the ground floor side panels being rendered over. The freestone repairs are currently adequate, although further improvement will be required by a stonemason within 5-10 years.

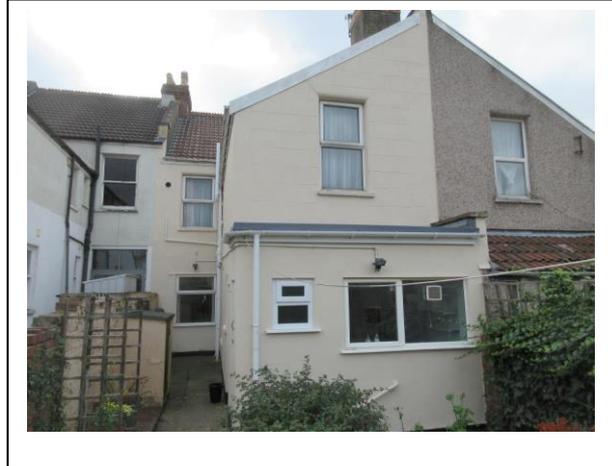
9. The walls of the back addition measure 270mm in thickness and are constructed of solid brickwork. The render has been continued down to the base of the walls and a bellcast should be formed.

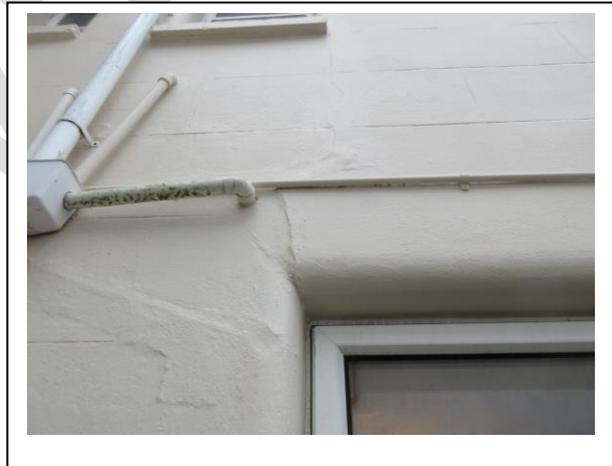
10. There is evidence of some movement above the breakfast room window opening and the crack has been filled in the past. The movement is not considered to be of a significant nature.
11. The opening is of a poor design and it should be re-formed to prevent water from running into the window which could result in deterioration of the timber lintel above the opening.
