BUILDING SURVEY REPORT

123 That Street

29 April 2021

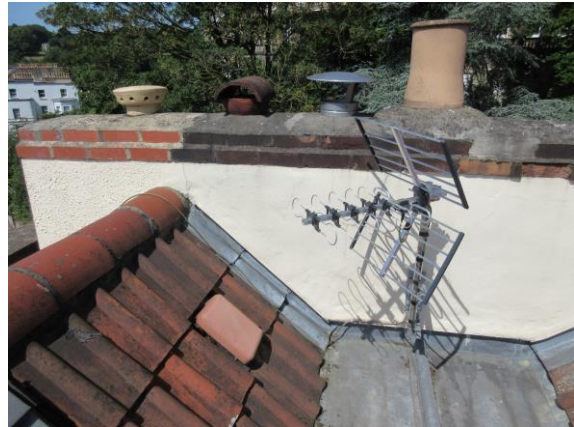
1. There is a large central chimney stack which is mostly rendered. The render finish is hollow and the defective render should be hacked off and renewed to prevent dampness occurring internally.

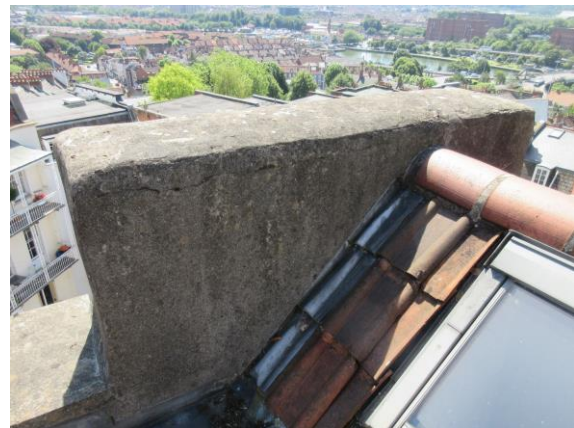
2. The brickwork at the top of the stack is a mixture of ages and a number of eroded bricks will need to be replaced when the render is renewed. The flues have been fitted with various different pots, whilst others are capped off, and the pots are all adequate.
3. The old eastern stack is rendered and it has been fully capped. The render capping to the stack is of a basic quality which could allow water penetration to occur and ideally extending coping stones should be fitted upon the stack to avoid any water penetration issues. As this stack is no longer used it would be sensible to have it taken down below roof level.

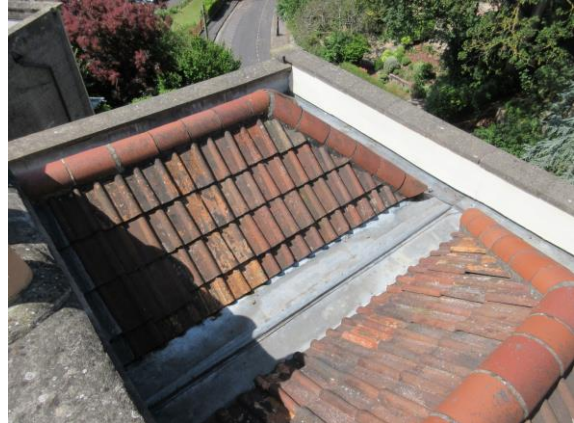
1. The main roof is formed in two halves, separated by the central chimney stack, and the front and rear sections each have two small pitched roofs. The pitched roofs are covered with double roman clay tiles, approximately 20% of which are badly worn and will need replacement within the next 1-2 years.

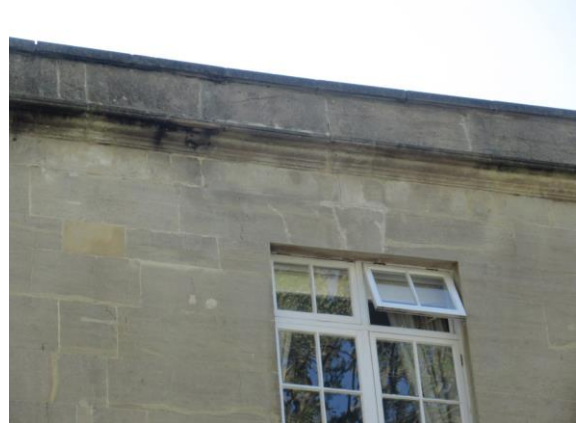
1. The front parapet wall is constructed of ashlar and fitted with stone copings. The parapet wall is in satisfactory order, although gaps between the copings should be filled to avoid water penetration. The projection at the base of the parapet wall should be covered in lead as ashlar is a porous material and water resting upon the stone can penetrate the wall and lead to dampness occurring internally.

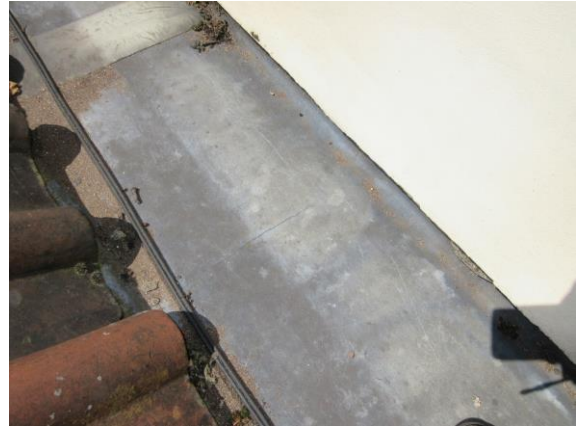
2. Various flashband patches have been added to the gutters, indicating previous leakage has occurred, and proper repair by fitting expansion joints will be necessary. The section of the front parapet gutter, above bedroom 1, is splitting and repair is now required.

3. Parapet and central gutters tend to suffer from leakage and you should accept that ongoing maintenance and repair of these gutters will be required. A general overhaul of the existing gutters and fitting rubber expansion joints will be necessary within 1-2 years and estimates should be obtained from a building contractor for this work prior to exchange of contracts.

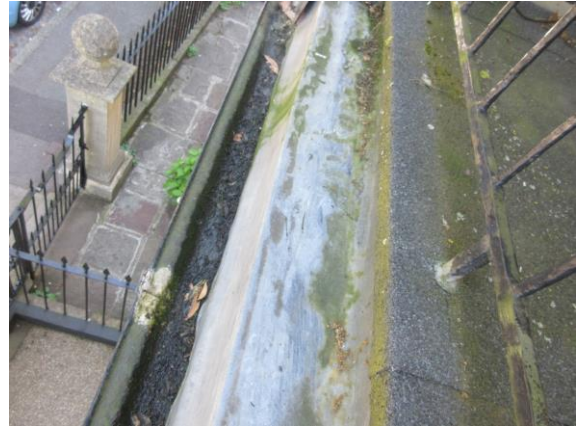
2. There is an old cast iron section of guttering to the porch roof which discharges on to the path. The cast iron gutter should be cleared of debris and regular maintenance will be required.

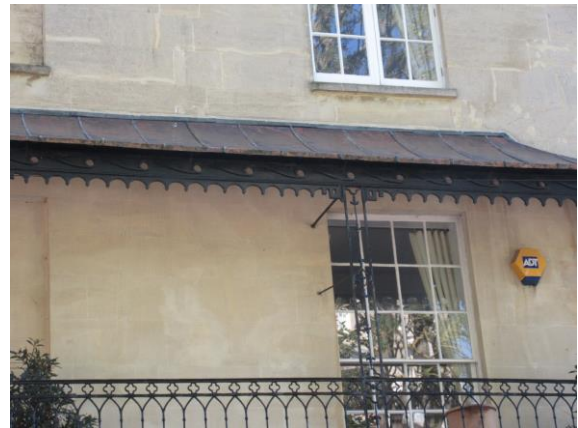
1. The front elevation is constructed of solid stonework measuring approximately 450mm in thickness at first floor level. The wall is faced with ashlar blocks and the stonework is in fairly good condition, suggesting it has been overhauled in recent years. Ashlar is a soft material which deteriorates as it ages and regular patching and repair of the stone will be required by a stonemason.
2. The ashlar blocks are fixed to the walls with metal ties which tend to rust as they become older; regular replacement and repair of these will be required by a stonemason.

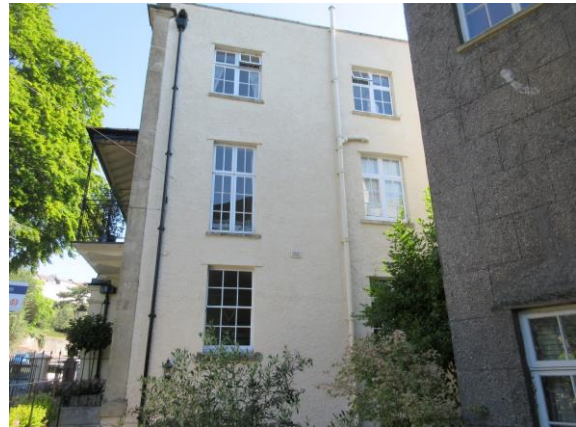
6. The side elevation is rendered, and the finish is probably at least 30-40 years old. The stone sub-sills below the window openings have been re-surfaced and the drip grooves are basic; ideally they should be re-formed to prevent water from running down the walls.

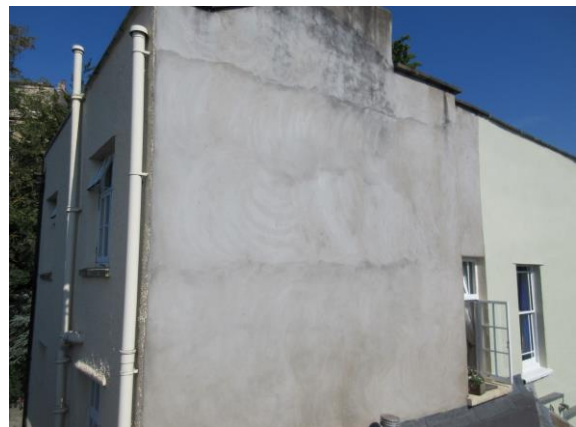
10. The rear wall of the property is only visible at top floor level from the neighbour's flat roof. The wall is rendered externally; the finish is modern and in satisfactory order. There is some minor crazing at the top of the wall adjoining the chimney stack and eventual renewal of this render will be required should any water leakage occur.

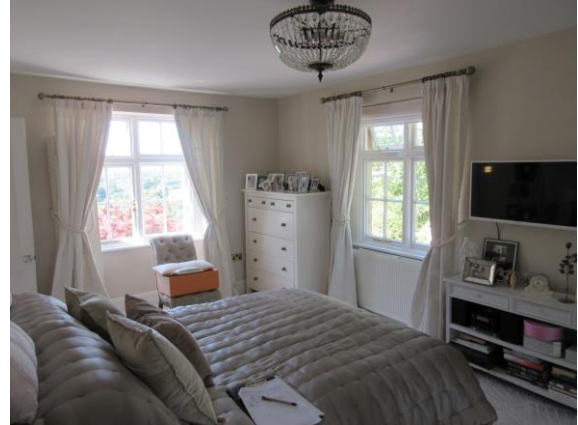
2. All remaining windows are of a timber casement variety and they are generally in satisfactory condition. We suspect that the original sash windows have been replaced in the past and, whilst planning consent would be necessary if this work were to be carried out now, it appears that some of these windows may be particularly old and pre-date these requirements.
3. The timber casement windows are in basic condition in some areas and localised repainting will be required within the next 1-2 years.
4. The low level windows within the first floor living room, to both the front and side elevations, are a safety hazard and new safety glass should be fitted within the lower panes.

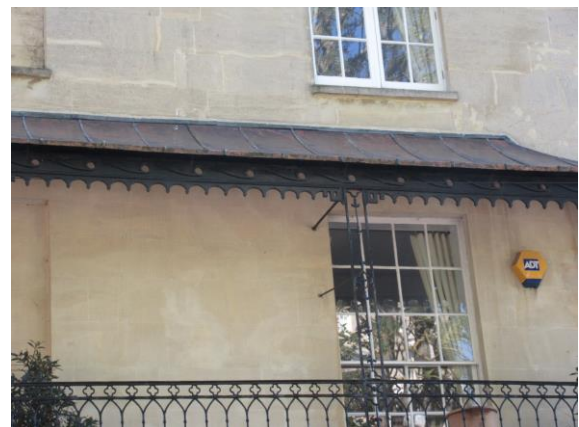
1. The front balcony is constructed with a timber base supported upon timber brackets and the balcony extends over the porch effectively forming its roof. The base of the balcony and porch is covered with a felt surface which is satisfactory, however felt is a fairly basic material to use as it has a lifespan of 10-15 years. Ideally a more durable lead surface should be provided in future.

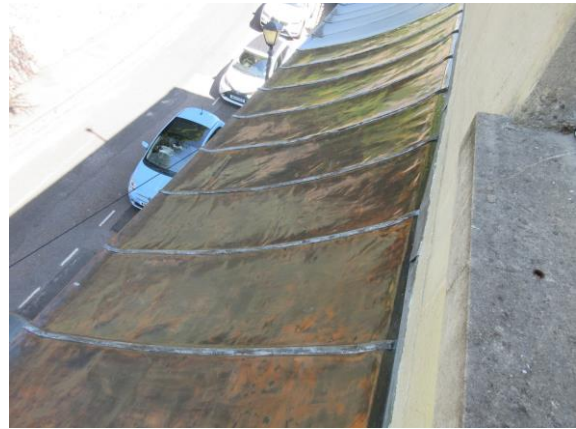
2. The metal framework to the balcony has been decorated and is presented in good condition for its age.
3. The copper roof covering has been treated on behalf of the vendor and appears to be covered with a stain which is likely to wear over time. The copper roof covering is currently satisfactory.
