# Maggs & Allen

## **Building Survey Report**

Sample Property

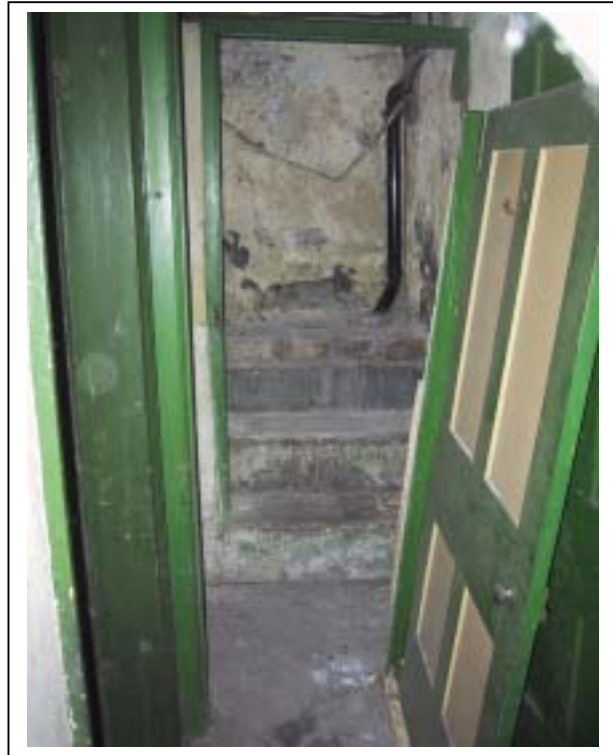
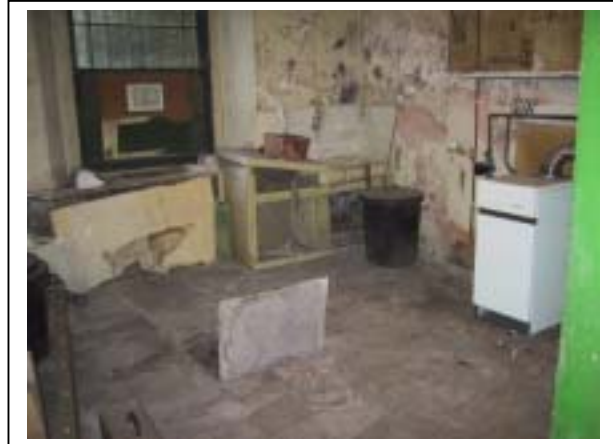
1. The destination of the surface water is not clear, the downpipe from the front elevation appears to discharge into a collection chamber to the front right hand side basement area. This requires further investigation to confirm the nature of the drainage system to this area. There is a small access point, possibly for rodding purposes, but this was found to be rusted shut and we were unable to raise. There is a further, now redundant, water store under the flagstone floor of the basement utility. We would advise this now be filled.

2. It appears that downpipes to the front right hand side elevation discharge into some form of surface water drainage system but the downpipes from the side entrance porch and to the rear left hand side corner currently discharge directly onto the site ground which is not a satisfactory arrangement and we would advise that these are also connected to a surface water drainage system or soakaway.
3. All downpipes should discharge into enclosed gulleys to avoid splashing and consequential damp penetration.

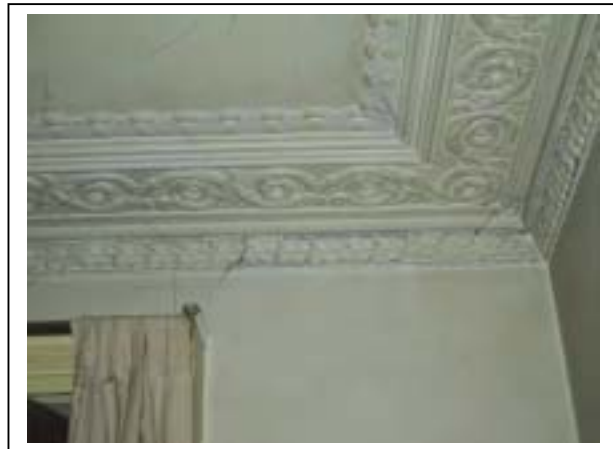
4. There is some more notable cracking and crazing to the main rear reception room, it appears that some local loss of key is occurring, we would advise that you budget for replacement but it may well be sufficient to either skim over or paper this ceiling in order to retain. The plasterwork detailing is in generally good order but some local repair works are required to the rear wall due to previous movement problems.

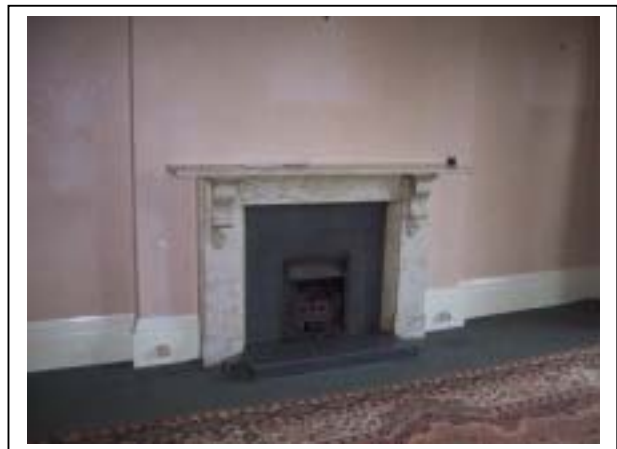
1. The building does retain a wealth of the original fireplaces and these are mostly in quite reasonable condition, although some partial reinstatement and repair works are required, particularly to the front reception, there is currently a very dated tile insert section. Some of the fireplaces are also boarded which prevented a full inspection. We did note that the fireplace mantel requires replacement to the small rear reception and there is a considerable amount of debris collecting within the first floor flues which requires clearing out.

2. The cast iron insert also requires repair to the small rear reception.
3. Fireplaces that have been or are to be blocked in should be fitted with ventilation to prevent damp and condensation building up within the flues.

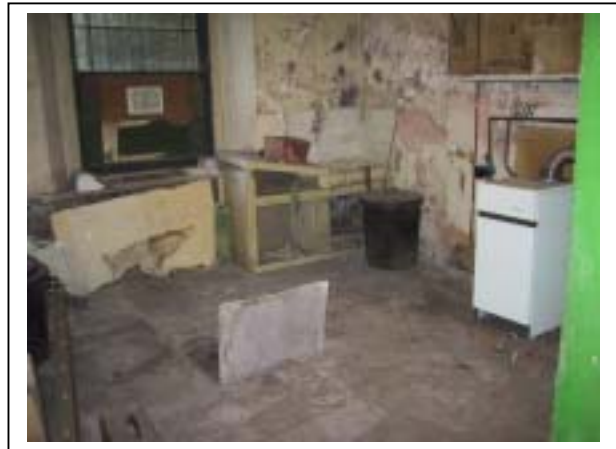
5. The basement floors to the front of the building are of part quarry tile, part flagstones. These floors are extensively worn, very uneven, there is no damp proof membrane beneath and they are also suffering from extensive penetrating damp problems. These floors now require relaying, also including the filling in of the redundant, what appears to be, water storage cistern within the main front basement room.

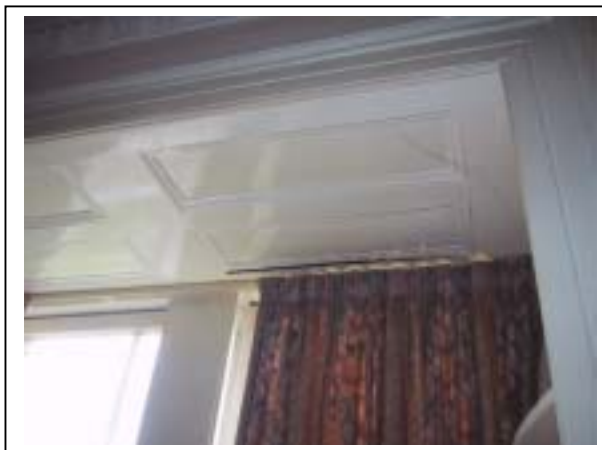
2. Some slight warping and splitting was noted to the panelling over the front bay, this is believed to be attributable to previous leakage problems. This area was found to be dry and the woodwork sound, with no evidence of any rot problems.

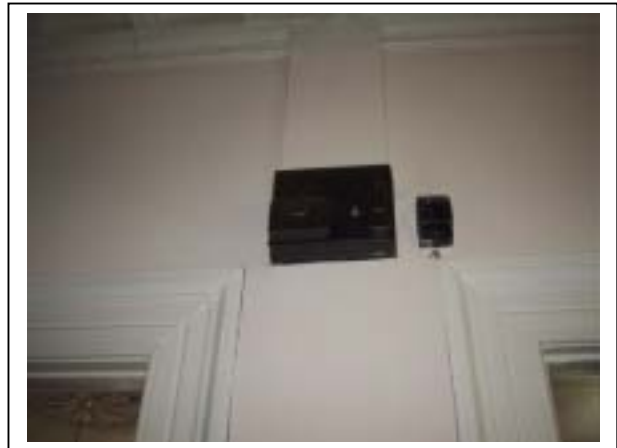
1. There is a basic electrical system, mostly modern wiring was noted but the fittings are generally obsolete, very dated, and the general distribution is inadequate by current standards. Consumer protection is also currently by way of rewirable fuses which is again fairly obsolete by current standards.

2. We are of the opinion that the building now requires comprehensive rewiring in order to bring up to acceptable standards and estimates should be obtained.

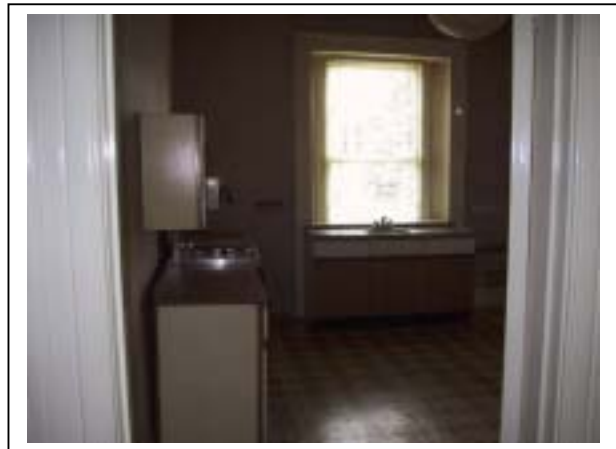
1. Kitchen fittings are poor, comprehensive refitting is now required and estimates should be obtained. In our experience this is currently very costly.

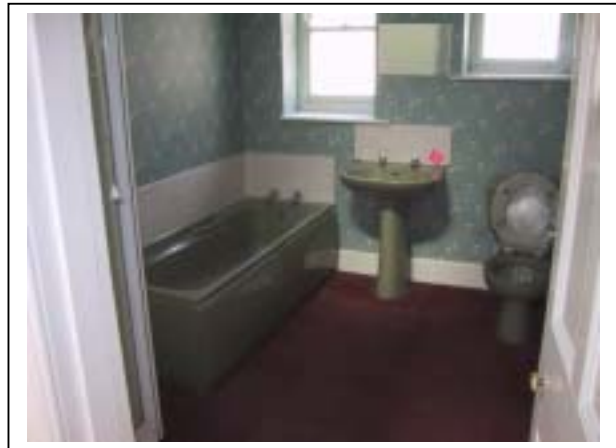
1. The sanitary fittings, although serviceable, are clearly out of keeping with a property of this type and upgrading is now required.

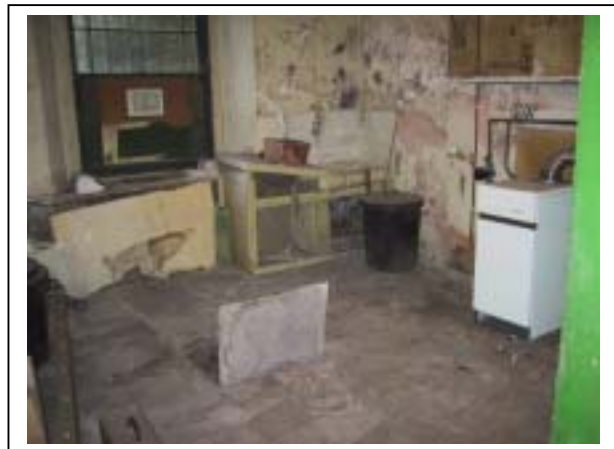
3. There are further wet rot problems to the basement side windows, also to some of the box framework to the bay sash windows, and highly likely to the base of the sashes at the front basement level but these were not accessible. The window sills at basement level are also in poor condition, having completely disintegrated to the front basement area. Rot affected timber sections should be replaced in conjunction with the renovation.

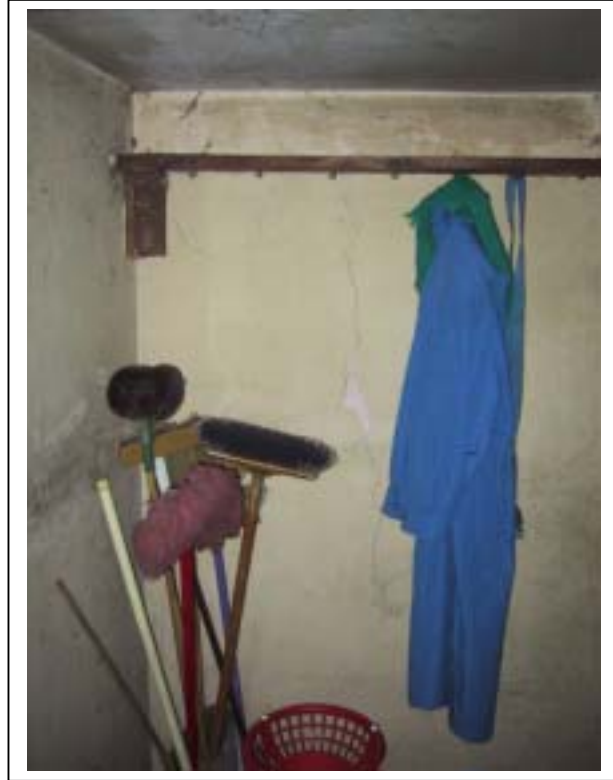
1. Movement was noted to the building by way of general distorted window and door openings, cracked lintels and stone detailing, and also some internal cracking, most notable to the side party wall, but also locally again adjacent to window and door openings, and also slightly uneven floors.

2. The cracking noted to the building generally did not exceed some 5-10mm, the majority of 1-2mm in width. It is evident that the building has been considerably neglected, no attempt has been made of any significant repairs and we are of the opinion that this movement is attributable to the natural settlement of the building and general lack of maintenance, and it is not considered to be a progressive problem. The

likelihood of further significant movement occurring to the building is remote, although some inevitable seasonal movement will occur, causing some slight cracking and crazing, but only further routine maintenance work is considered necessary.
